Filing Code 1525 (P-401)

July 1969

Bureau of Land Management U.S. DEPARTMENT OF THE INTERIOR

FORD TRUCKS - PARTS AND SERVICE RECOMMENDATIONS [Port]

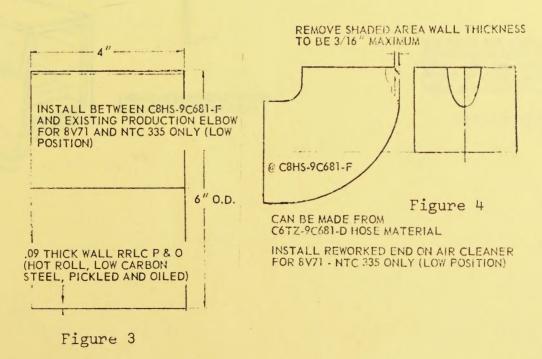
Chart 1 and Figures 3 and 4 list parts required to convert the oil bath air cleaner with minimum rework. The parts listed are DSO or RPO released.

Chart No. 1 Part Number	Part Name	Usage	Requirements
@C7TS-9600-A	Air Cleaner Assembly	NH, NHC, 6-71, 1673	1
@C7TS-9600-G	Air Cleaner Assembly	8V71, NTC 335	1
@*C8HS-9C681-E	Hose	8V71, NTC 335	1
*Fabricate — See	Sleeve	8V71, NTC 335	1

^{*} Parts are required to adopt new cleaner to the existing system. The oil bath cleaner for the 8V71 and NTC 335 engines incorporated a metal elbow. The new dry cleaner does not have the metal elbow and therefore the additional rubber elbow and sleeve are required to complete the installation as shown in Figures 3 & 4. The rubber elbow must be reworked by removing a small section of rubber as shown in Figure 7 to allow the hose to properly fit onto the cleaner outlet.
